SERVICE BULLETIN NZ SB129

**Units affected: MHP13/35 & MHP15/44 built before S/N
NZ060201 and fitted with Robin EX17 or EX21 petrol engines**

UPGRADE

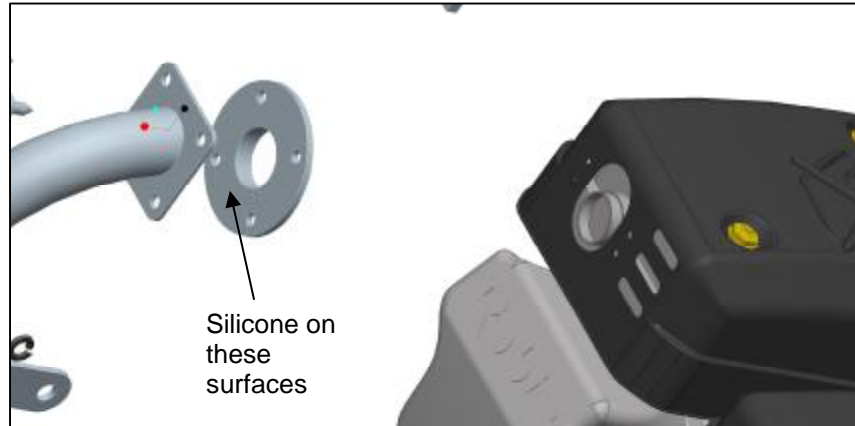
**Exhaust gas is getting sucked into the air intake on the Robin engines
and is causing poor engine performance.**

The small outer diameter on 12539-50 faces towards the engine and fits over the engine's exhaust tube.

**To minimise any potential exhaust gas near the air intake Snorkel
part number 12539-50 is required to be fitted between the Robin
exhaust and the exhaust pipe. A high temperature silicone sealant is
also required (such as Master #7 Gasket Maker)**

- 1. Detach the exhaust pipe from the engine.**
- 2. Loosen the 3 bolts holding the exhaust heat shield to the engine.**
- 3. Run a bead of silicone around the engines exhaust, around the inside diameter of 12539-50 and on the outer flange as shown in the diagram, leave to skin as per the silicones instructions.**
- 4. Reassemble the exhaust to the motor with 12539-50 located between the exhaust pipe and the engine 's exhaust heat shield.**
