SERVICE BULLETIN NZ SB134

Units affected: MHP16T Trailers

MANDATORY INSPECTION

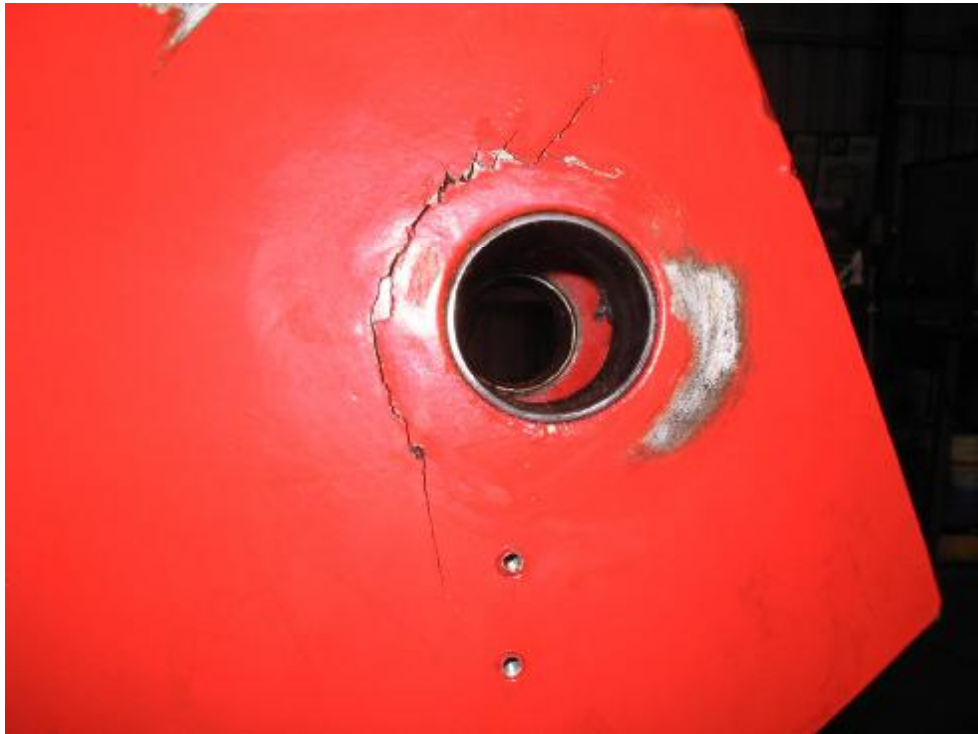
Figure 1

We have had reports of cracks appearing in the "outer boom" where it pivots at the Column.

Please carry out a through inspection of the outer boom pivot boss area for any evidence of cracking [refer fig 1 & 2].

If cracks are found remove the machine from service and contact an approved Snorkel Service agent for an appropriate repair procedure.
