SERVICE BULLETIN NZ SB134

Units affected: MHP16T Trailers

MANDATORY INSPECTION

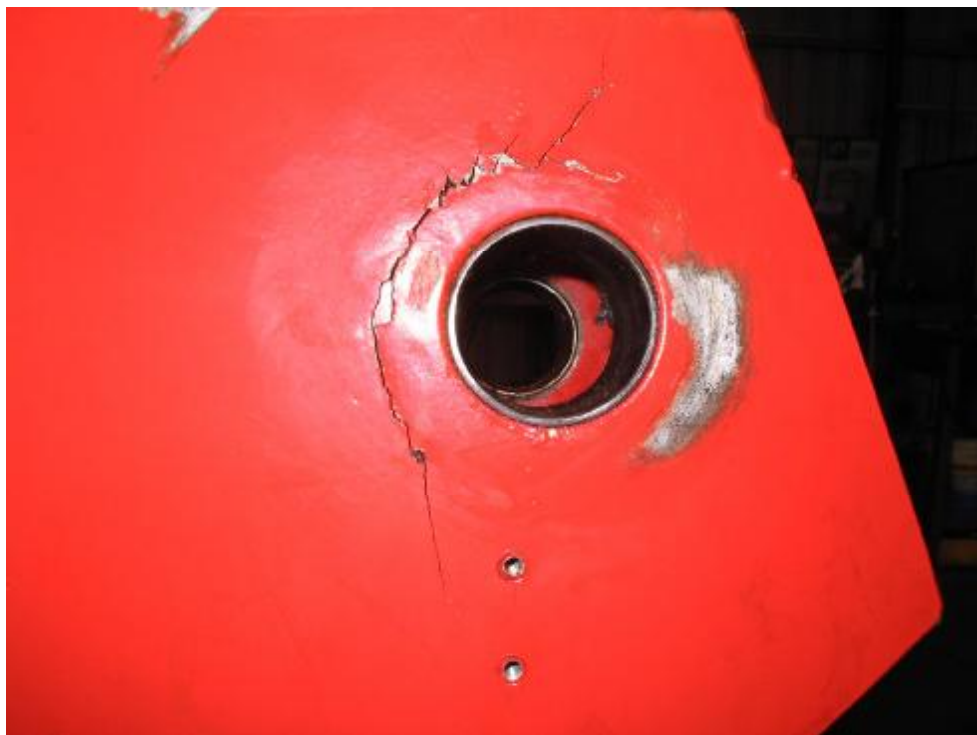
Figure 1

We have had reports of cracks appearing in the "outer boom" where it pivots at the Column.

Please carry out a through inspection of the outer boom pivot boss area for any evidence of cracking [refer fig 1 & 2].

Note: In order to inspect this area correctly the "boom end cover" must be removed. Removing this cover will expose the inside of the outer boom.

If cracks are found remove the machine from service and contact an approved Snorkel Service agent for an appropriate repair procedure.
