SERVICE BULLETIN NZ SB137

Units affected: MK2 MHP13/35 & MHP15/44 built prior to Serial number NZ070403

MANDATORY INSPECTION & MODIFICATION

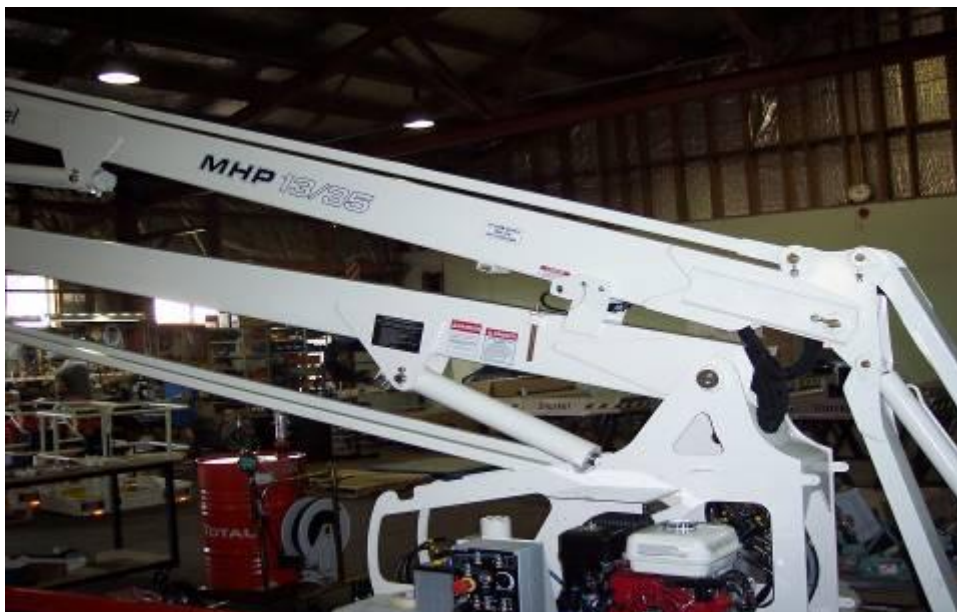
Fig 1 shows where the boom must be placed to check the pinkeeper clearance.

This requires the lower boom to be raised approx 2 meters from the boom rest and the upper boom "fully lowered" onto the upper boom "boom rest".

Fig 1 – Booms in position for checking pinkeeper clearance.

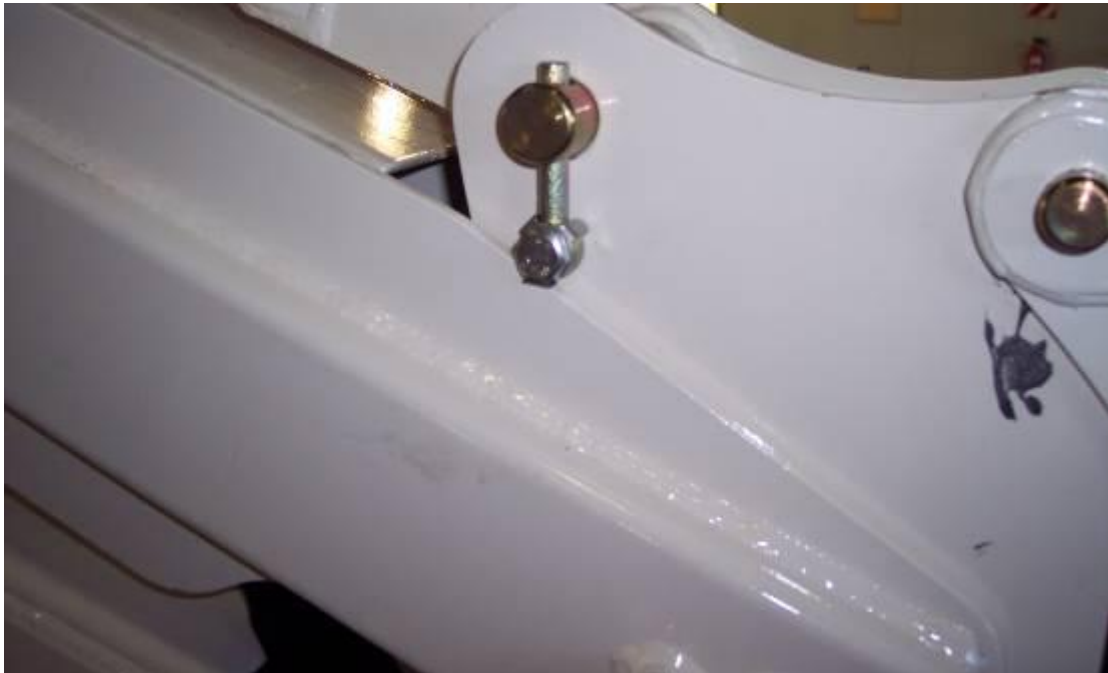
On some machines it is possible for a pinkeeper on the upper levelling quadrant to "touch" on the edge of the Upper Boom when the boom is placed in a certain position.

With the booms in this position the pinkeeper on the upper levelling quadrant will come very close and in some cases touch the edge of the upper boom [refer fig2].

Fig 2 - Pinkeeper touching the edge of the upper boom.

Any units found where the pinkeeper is touching the boom must be removed from service until the following modification has been carried out.

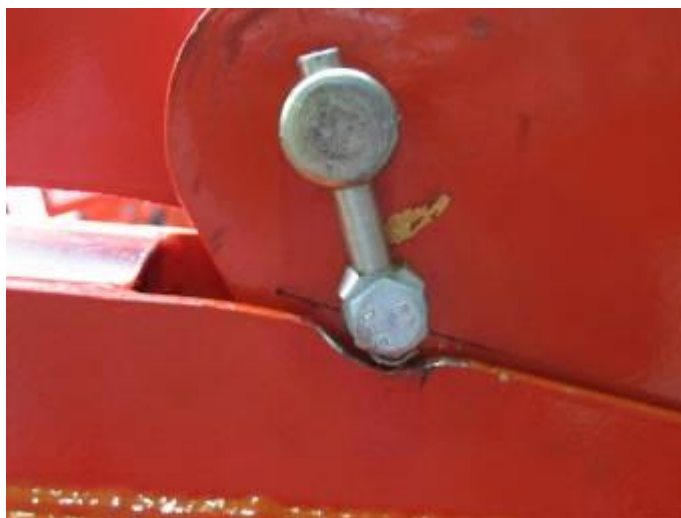
Fig 3 - Upper Boom ground away to provide clearance.

A small amount can be “ground” off the upper boom edge to give clearance for the pinkeeper. Note that when grinding the boom it is important to ensure that a smooth “radius” is achieved, refer to fig 3.
