SERVICE BULLETIN NZ SB142

Date: 26 May 2009

Units affected: All TM12 units built in New Zealand as per the list attached.

MANDATORY MODIFICATION

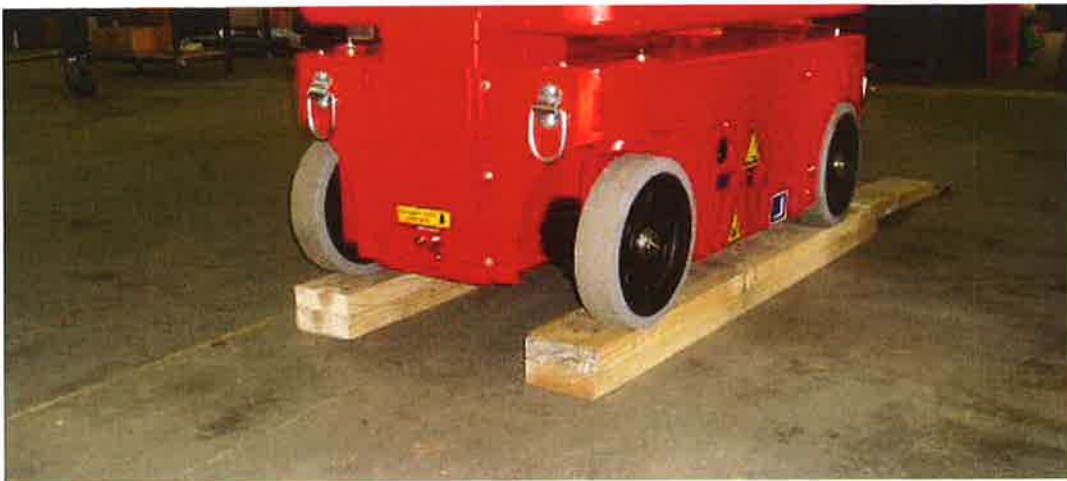
Fig.1 Machine driven onto planks of wood.

Drive the machine onto some planks of wood as shown to raise the machine enough to gain access to the bottom of the Mast [refer fig.1].

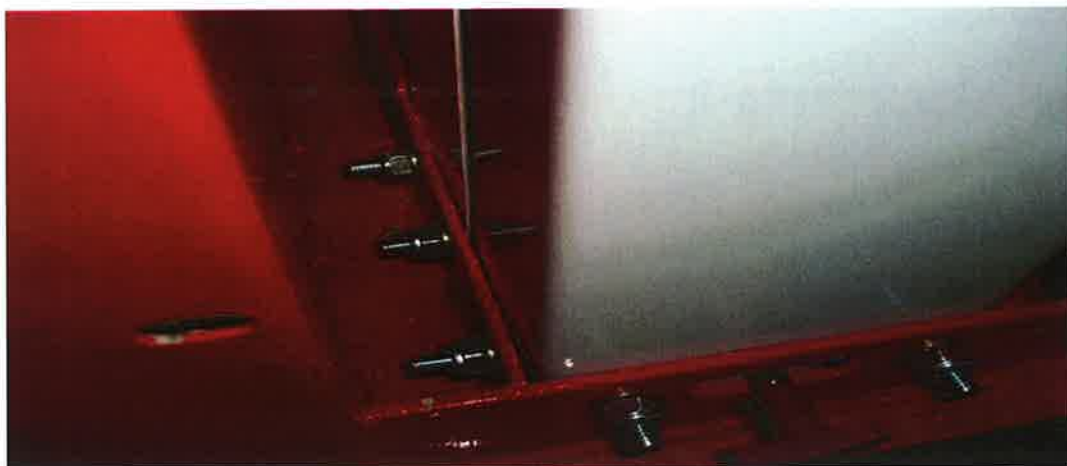
The bolts at the rear on either side will remain GR8.8 [refer to fig 2].

Fig.2 Location of left hand mast bolts. Note the one at the rear does not get changed.

Remove and replace the bolts one at a time, note that the new GR10.9 bolts must be done up to a torque setting of 69Nm [50lbft].

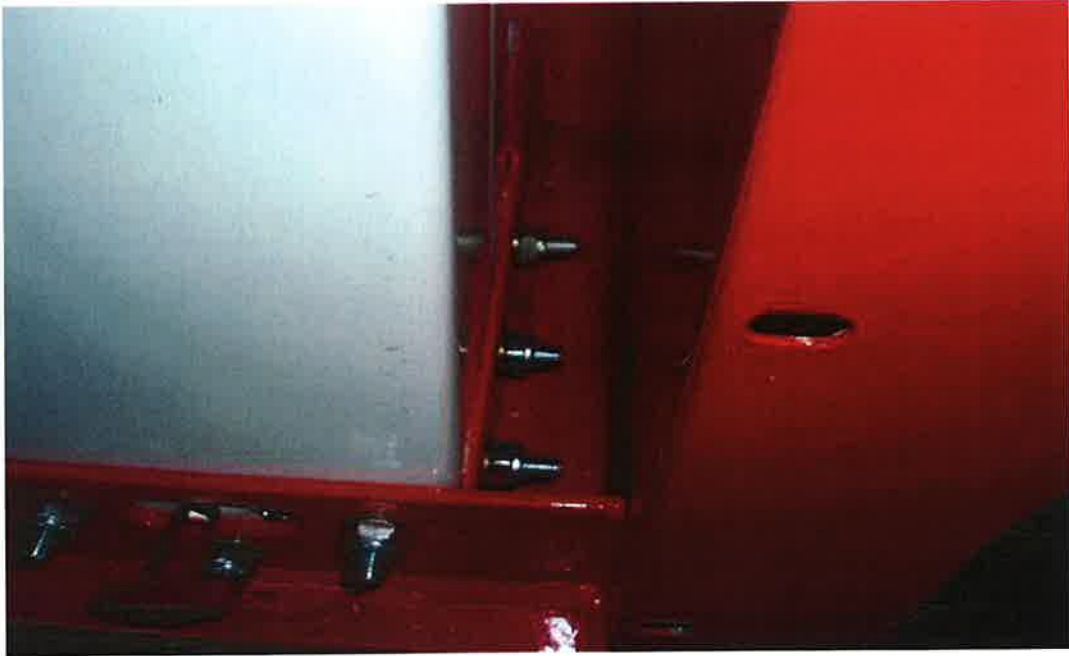
Fig 3. Location of right hand mast bolts. Note the one at the rear does not get changed.

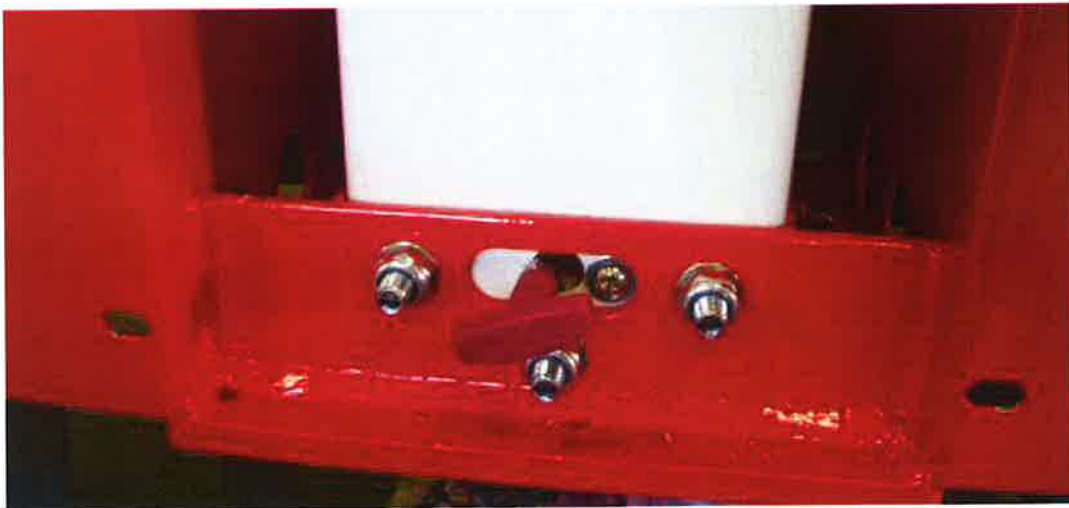
Fig 4. Location of front bolts [to be changed].

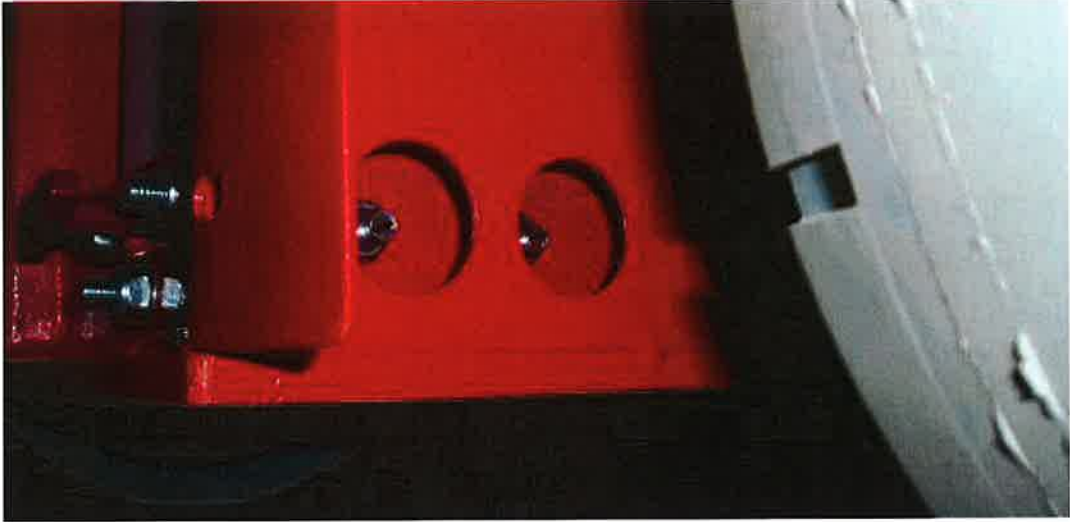
Fig. 5 Access to the side bolts can be gained through the holes in the side of the chassis.

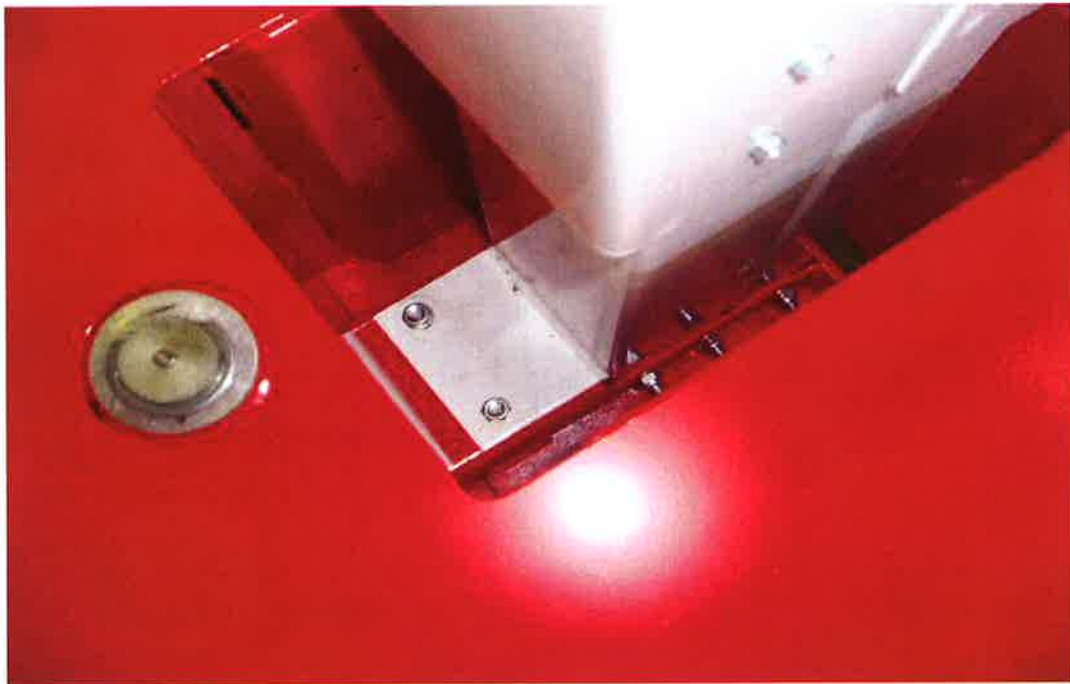
Fig.6 location of rear mast bolts [to be changed].
