SERVICE BULLETIN NZ SB142

Date: 26 May 2009

Units affected: All TM12 units built in New Zealand as per the list attached.

MANDATORY MODIFICATION

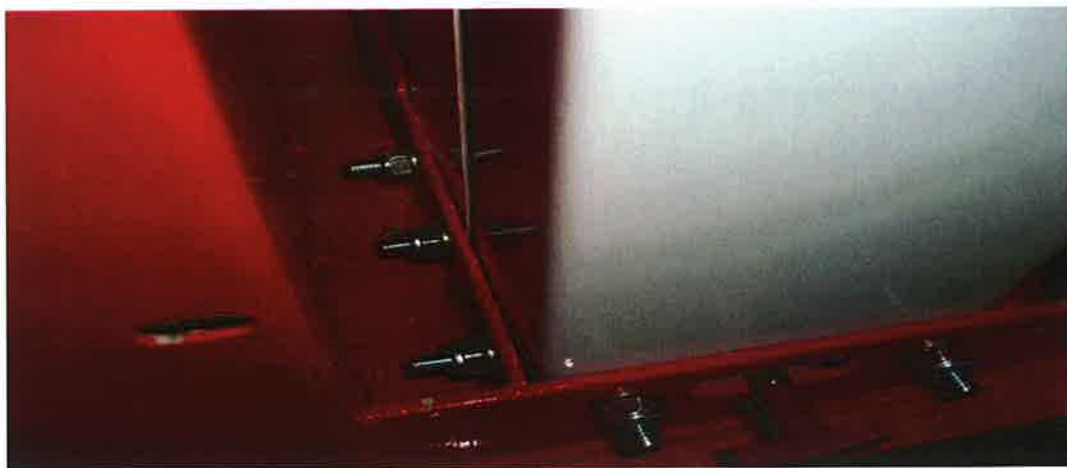
These machines have the incorrect grade of bolts fitted at the bottom of the mast assembly. These bolts must be replaced with a 10.9. grade not 8.8 which are currently fitted.

Fig.2 Location of left hand mast bolts. Note the one at the rear does not get changed.

The bolts at the rear on either side will remain GR8.8 [refer to fig 2].

Remove and replace the bolts one at a time, note that the new GR10.9 bolts must be done up to a torque setting of 69Nm [50lbft].

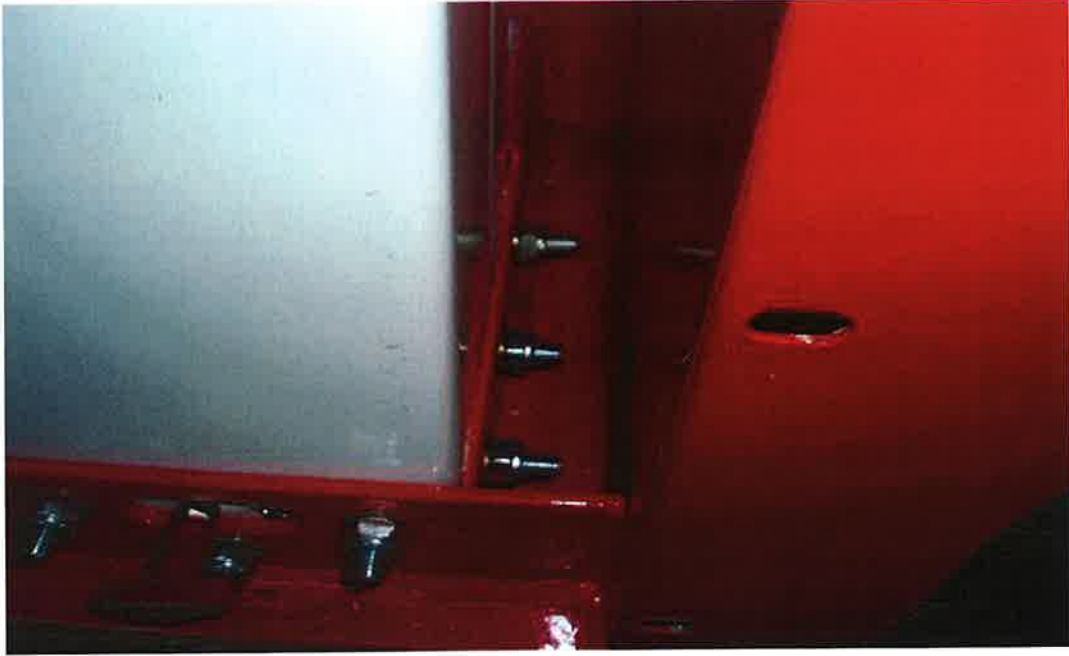
Fig 3. Location of right hand mast bolts. Note the one at the rear does not get changed.

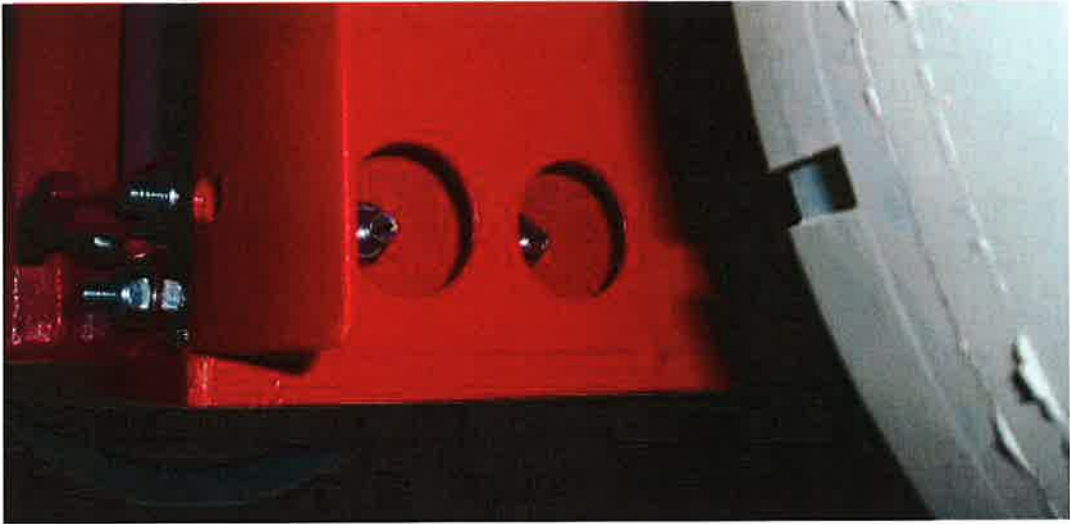
Fig. 5 Access to the side bolts can be gained through the holes in the side of the chassis.
