SERVICE BULLETIN NZ SB121

Units affected: ALL SR2770's built between Aug 2001 and Aug

2002

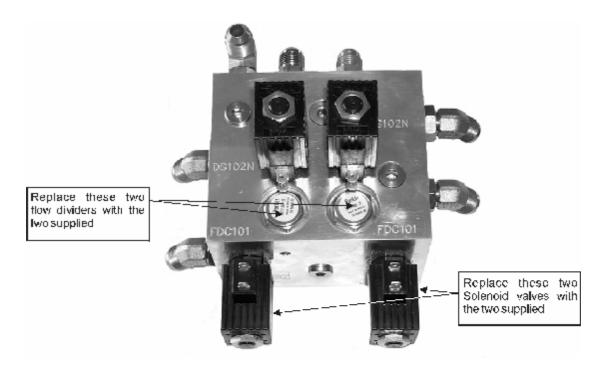
It has been determined that two of the solenoid valves and the two Flow divider/combiners used may be leading to problems when selecting the "high drive" mode. These valves can also cause "pressure spikes" which can lead to O'ring failures on the hydraulic drive motors.

The change consists of replacing two Flow Divider/Combiners and two Solenoid valves.

This picture shows which valves on the manifold need to be changed.

- Park the machine on firm level ground. Raise the scissor and put the safety prop in place. Place a suitable drip tray under the rear axle to catch any oil split.
- Remove the sheet metal cover at the rear of the machine to gain access to the Drive Manifold.
- Remove the valves as shown [refer to the picture attached] and replace with the valves supplied.

To minimize the amount of oil spilt, replace one valve at a time.

The coils must remain attached to the solenoid valve whilst these valves are installed as it is not possible to fit the coils once the valve is in place.

Do not over-tighten the valves, the correct torque setting is 22N.m [180In/lbs].

Once the valves are fitted, operate the drive function and check for oil leaks before replacing the cover and returning the machine to service.
