SERVICE BULLETIN NZ SB124

Units affected: SP18 & SP22 machines built before serial number NZ040901.

11818 Column Retrofit

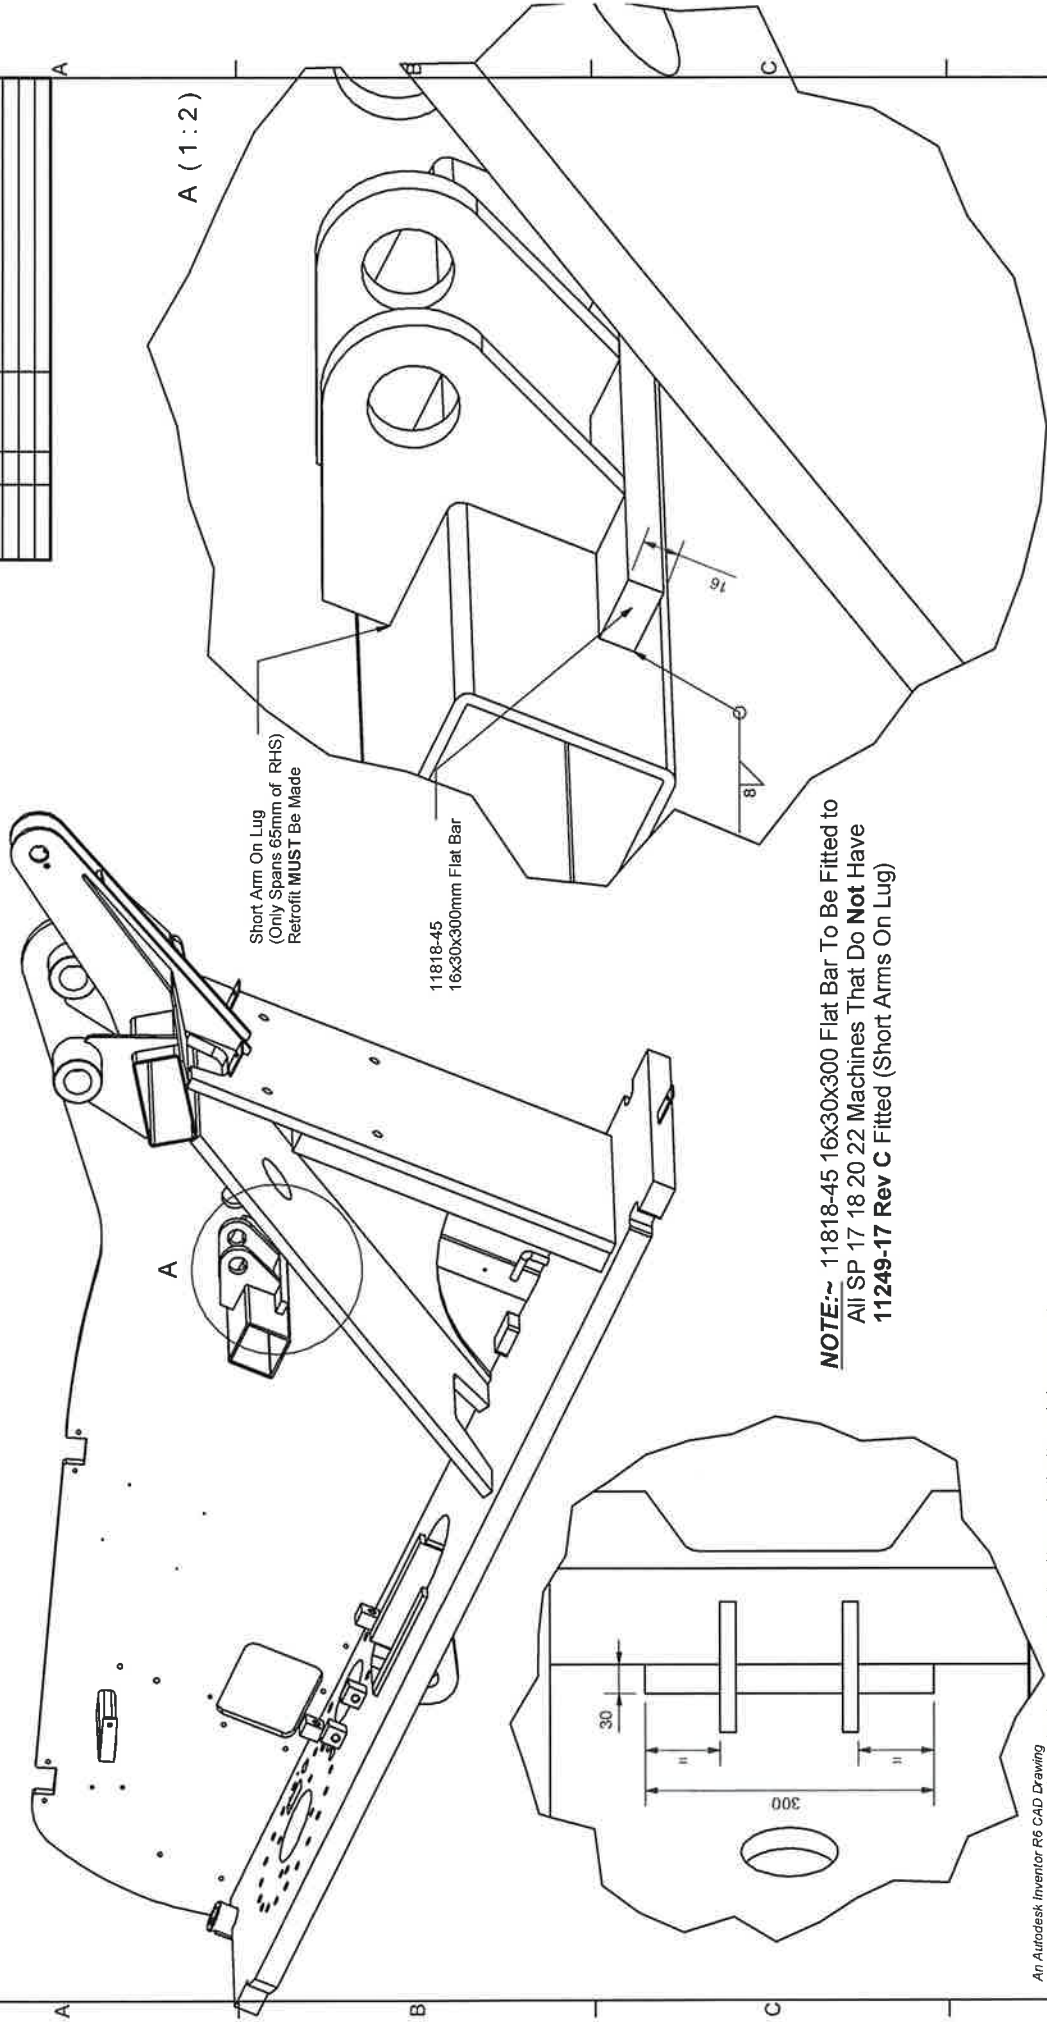
Stress cracks have appeared on some SP18 and SP22 units. These cracks appeared where the "master Level cylinder" is attached to the Column. The factory-approved repair when these cracks are found is to add a "gusset" [part # 11818-45] to the Cylinder mount as shown on the attached drawing.
