SERVICE BULLETIN NZ SB126

Units affected: ALL SR2770's built between Jan 2004 and Nov

MANDATORY INSPECTION

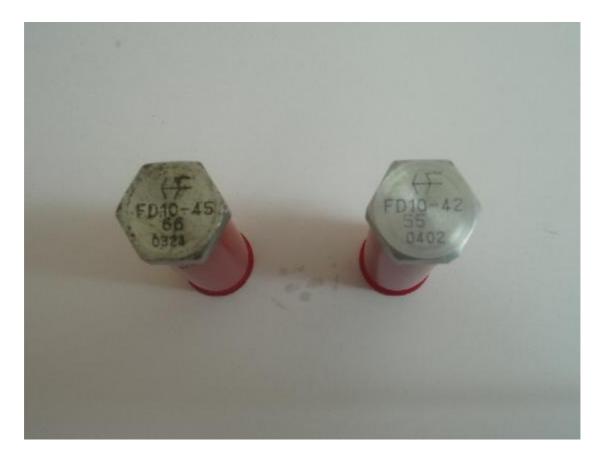
Fig.1

Some SR2770's produced during this period were fitted with incorrect Flow Dividers in the 4WD manifold.

The incorrect valves are marked as FD10-45.

The correct valves are FD10-42.

This picture shows the two different valves. The Valve on the left is the FD10-45, the valve on the right is an FD 10-42.

Any valves that are found to be incorrect must be replaced with the FD10-42 type.
