SERVICE BULLETIN NZ SB130

Units affected: SRT2670 & SR2770, built before August 2005

MANDATORY INSPECTION & UPGRADE

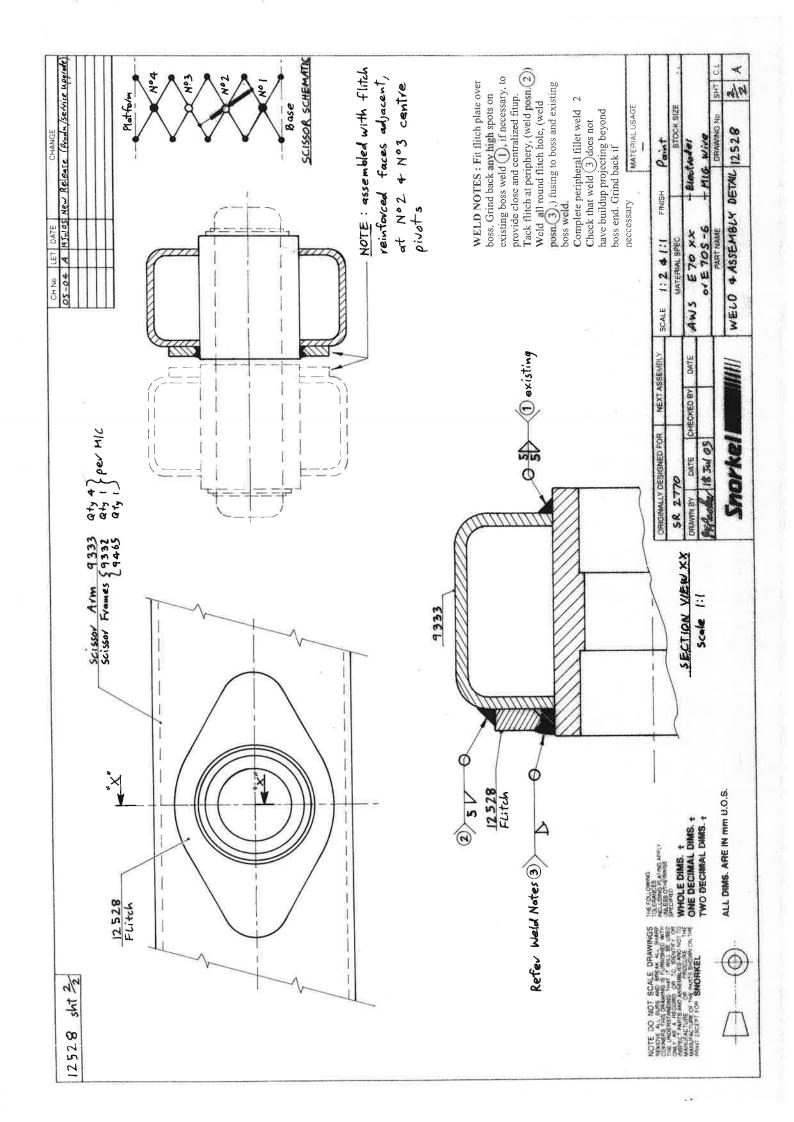
Insepct all of the centre pivot bosses on the scissor arms for evidence of cracking.

- 1. Check the scissor arm for bending. The usual cause of bending is lowering a load in excess of the SWL and stopping before the scissor is fully lowered.
- 2. Check the arms for obstructions, bent cylinder and crushed hoses/cables.
- 3. Check the Platform slider bar under the deck for damage/obstructions.
- 4. Check the Chassis sliders for damage/obstructions and or worn slide pads.
- 5. If the cracks in the arm carry on into the outer edge of the arm, the arm MUST be replaced.

Where cracks are found around the centre boss of an SRT Scissor arm the machine should be removed from service and the following weld repair procedure carried out.

Grind out any cracks around the boss in a "V" groove.

Weld the groove [refer to attached drawing for weld spec].

If the Cracks appear in Scissor stage 2 or 3 [from the bottom] add the flitch plate as per the attached drawings/procedure.

Only add the Flitch plate to Scissor Stage 2 & 3, [there is a total of 8 Flitch plates per machine].
