## **SERVICE BULLETIN NZ SB135**

**Units affected: MHP Trailers built October 2004 and July 2006**

### **MANDATORY INSPECTION**

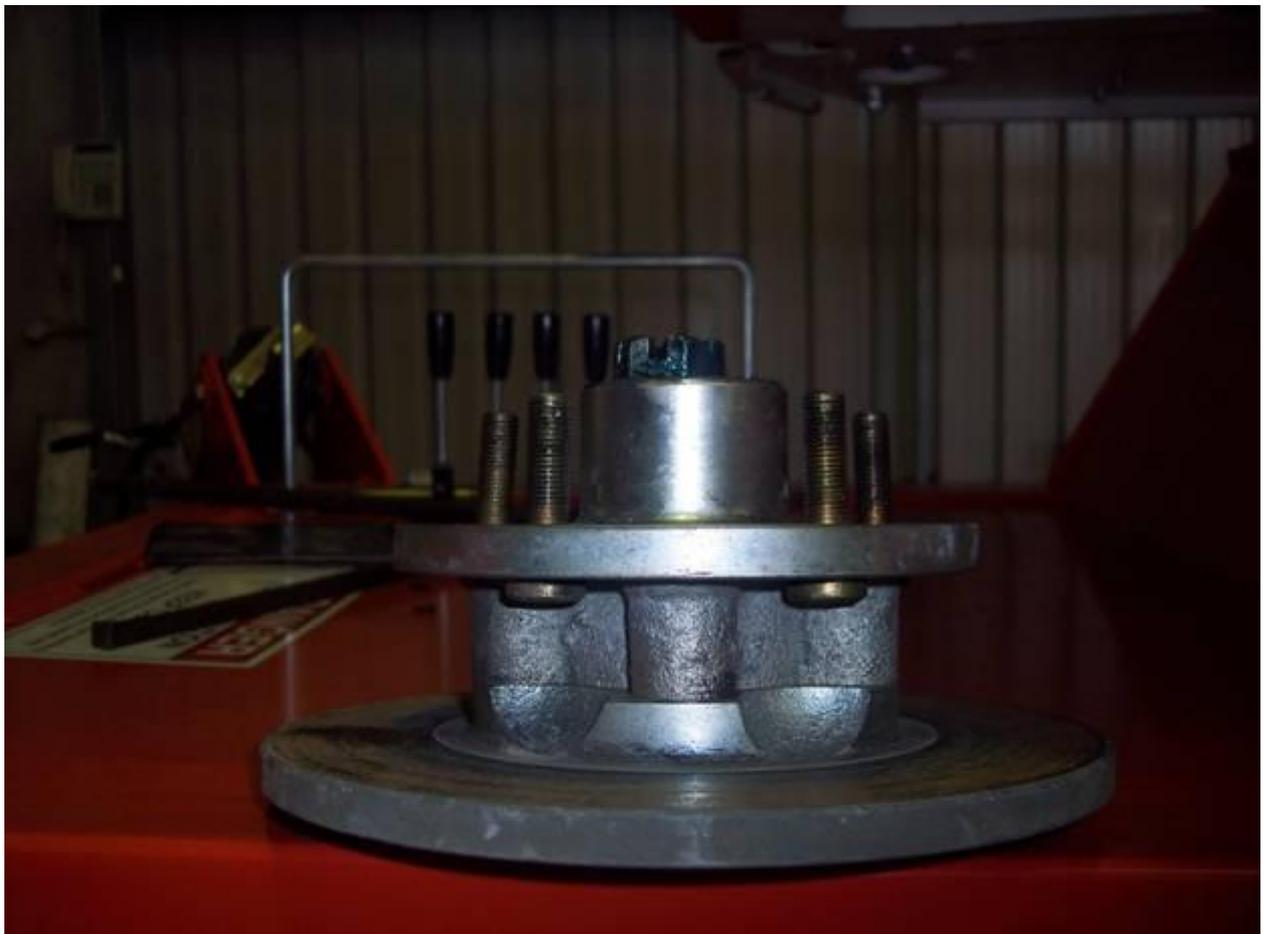
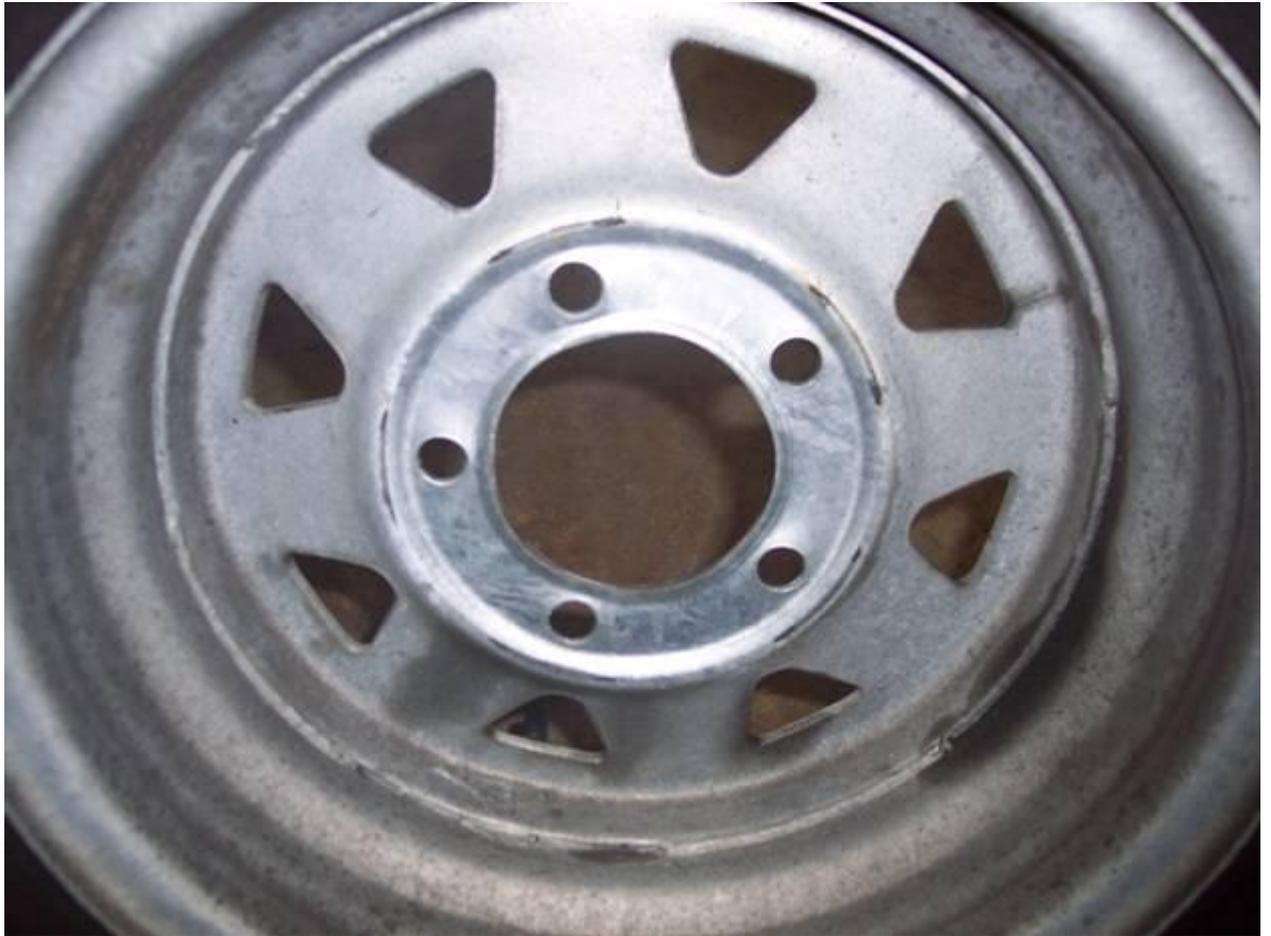
**MHP’s built during this period use a “Stylised Wheel Rim” which can become damaged if the Wheel Nuts are over-tightened. There has also been reports of Brake Rotors that have cracked.**

**The following pics show studs that have pulled "inwards" and a Wheel Rim that has a "deformed centre".**

**Any Wheel rims that are found to be “deformed” must be replaced [part 12361].**

**Any Wheel Studs that have pulled inwards or are bent must be replaced.**

**Once the items have passed inspection and/or been replaced the Wheels must be re-fitted and the Wheel Nuts done up using a Torque Wrench.**

**Note the Torque settings for the Wheel Nuts on MHP Trailers has been revised, it is now 50lbft [68Nm] for both 7/16" and 1 / 2" studs.**
